Berkeley Municipal Fishing Pier Accessibility Surface Project: Final Programmatic Report (Amended)

Recipient Organization/Agency: City of Berkeley

Date Submitted: July 28, 2016

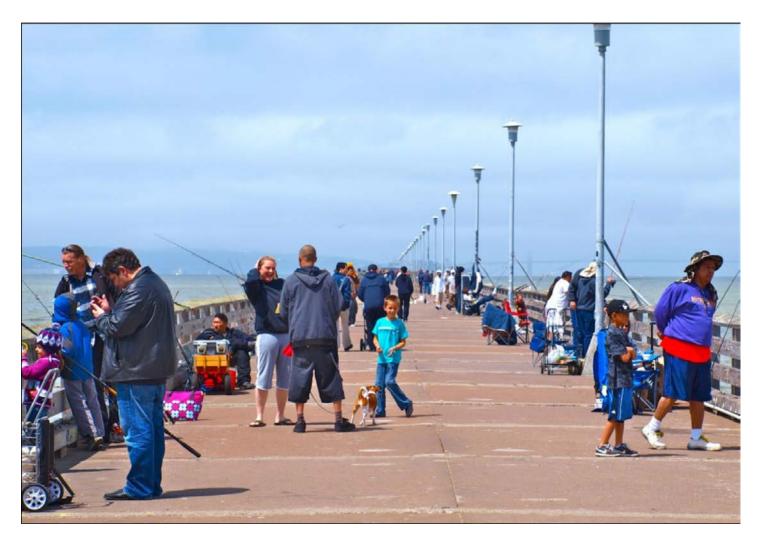
Image 5: The Pier is extremely popular for the public on any given sunny day, throughout the year. Based on several sources, the Pier receives over 100,000 visits per year. Note the uneven surface joints every fifteen feet. (Photo Credit: Ken Jones)

The need to improve the badly spalled and uneven concrete surfacing at the Berkeley Pier would have greatly improved the visitor experience to a wide range of users, including the disabled, the elderly, low-income fisherman, and other recreational users from throughout the entire region, totaling over 100,000 person visits per year.

When the City identified the problems of an uneven and spalled concrete surface at the Berkeley Pier, the proposed solution to grind and re-grout the uneven concrete joints was seen as an effective method to greatly improve accessibility of the pier to the public. Then, in 2015, the structural engineering assessment of the pier found that the concrete decking throughout the length of the pier had lost all of its structural support due to failed rebar, and could not even sustain its own weight. After further analysis, the structural engineering firm indicated that the uneven surface of the concrete decking was a possible indication that the structural rebar in the concrete decking had failed.

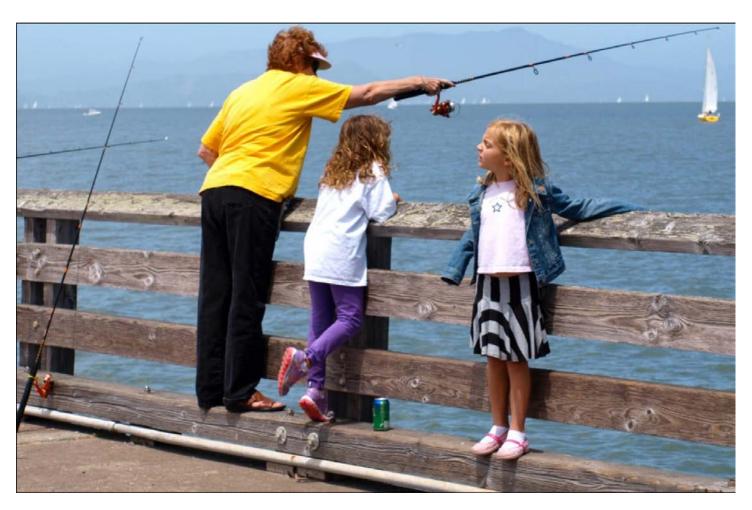
Image 7: At the Kids Fishing Derby in 2014, grandma shows the next generation how to cast off the Berkeley Fishing Pier. Note the tall height of the railing. Lowered rails would create easier fishing access for persons with disabilities. (Photo Credit: Ken Jones)

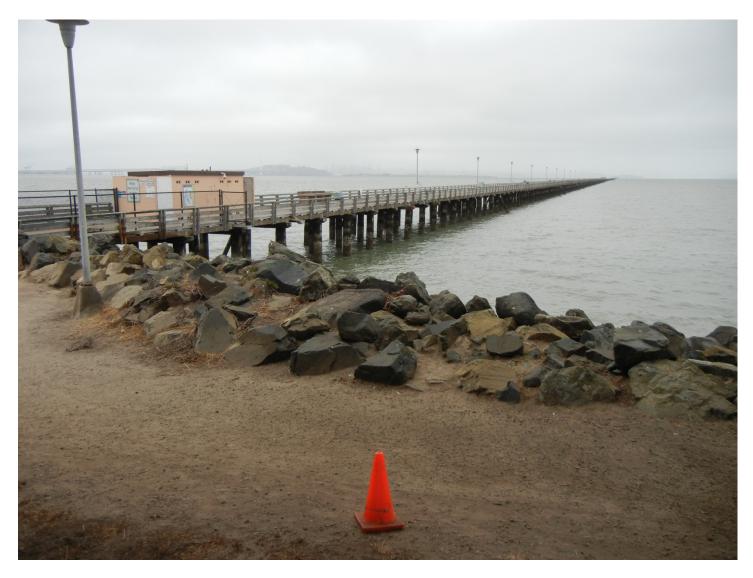
Image 11: After the closure of the Pier on July 22, 2015, the Pier is fenced off and closed to the public. In 2016, the City is conducting a structural study of the Pier for repair options. (Photo Credit: Roger Miller)

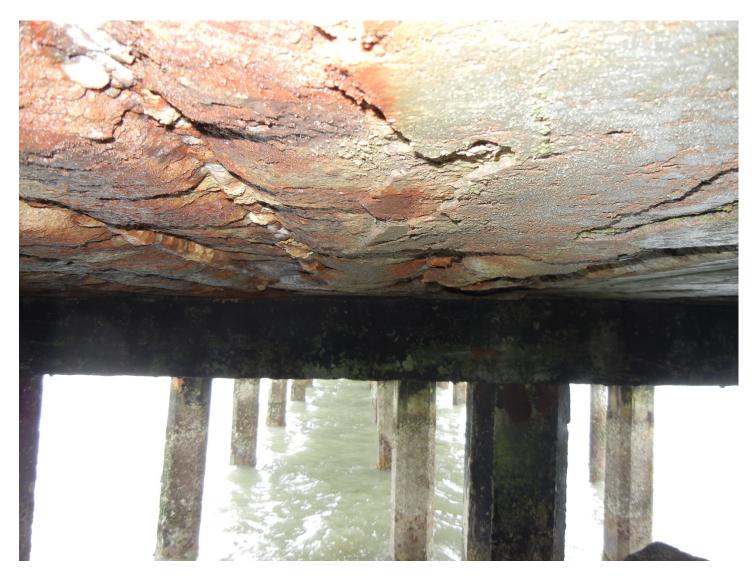
Image 14: On the underside of the concrete deck surface of the Pier, the bottom layer of concrete has spalled off, exposing the structural rebar, which has snapped and failed for the most part, throughout the entire length of the 3,000 foot Pier. On the upper right, see the partially remaining layer of concrete that was applied to the underside in 1984, to prolong the life of the structural rebar. (Photo Credit: Roger Miller)

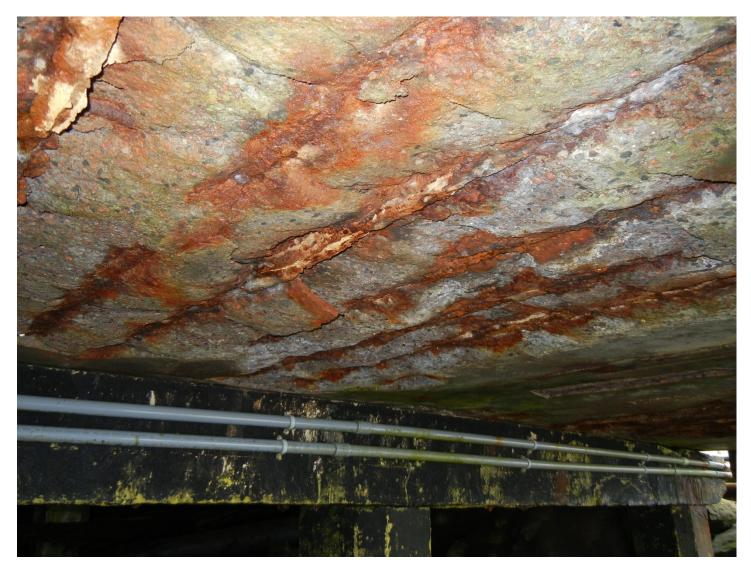
Image 15: A detailed photo of the rusted and snapped structural rebar on the underside of the concrete deck surface of the Pier. An independent structural engineering evaluation found that most of the structural rebar has snapped, leaving the Pier with zero strength to hold up the concrete deck surface, which required the City to close the Pier to public access. (Photo Credit: Roger Miller)

In the late Spring of 2015, the final design for the Berkeley Pier Accessibility Project was completed. Before the project was advertised for construction bids, the City undertook its annual preparation for the July 4th fireworks display at the Berkeley Pier. During preparations, an independent structural evaluation found that the concrete layer on the underside of the concrete decking surface of the Pier had spalled off significantly, exposing the structural rebar. A significant portion of the rebar has rusted and snapped, leaving the concrete decking surface with no strength to support the weight of the concrete. On July 22, 2015, the City of Berkeley closed the Pier to the public indefinitely until a repair can be developed and funded.

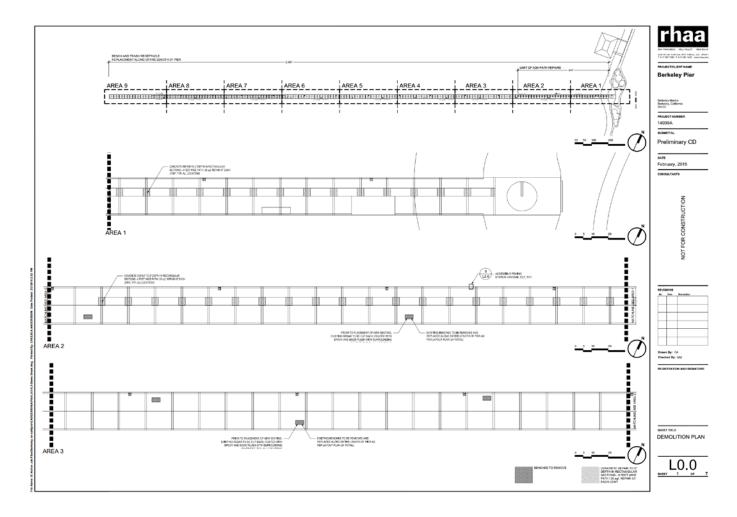
Image 16: The first page of the Berkeley Pier project design drawings by RHAA. The final plan for the renovation of the first 700 feet of the surface of the pier for improved ADA accessibility, plus 10 ADA accessible fishing stations. (Credit: RHAA Design)

The next phase of this effort will be to perform a structural analysis of the Berkeley Pier using City funds, and to develop a range of concepts and costs for a possible repair of the existing structure. Any future repair will incorporate the design that was produced by this grant, e.g., ADA accessible fishing stations and ADA accessible surfacing.
